BROEN-LAB TMV AND TMV SAFETY

General instructions for installation, maintenance and operation

94G0292 - 22.06.2026

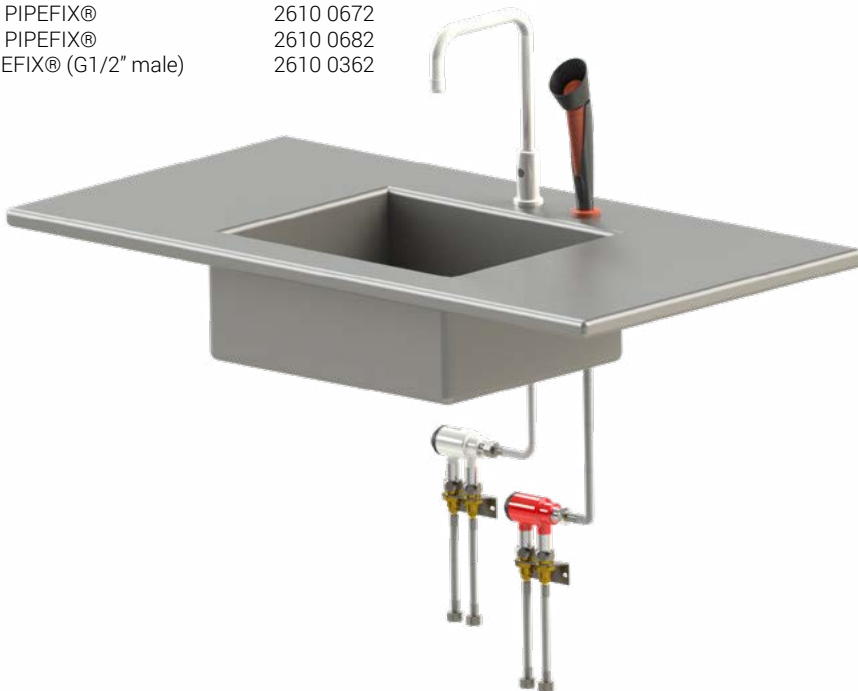
Illustration 2: TMV and TMV Safety installed under the sink

TMV, TMV Australia and TMV Safety can be installed in any position. Installation beneath the bottle trap is recommended due to space constraints.

Centre distance, inlets: 39 mm.
For space reasons, outlet pipes should be fitted last.
